# PRELIMINARY INVESTIGATION REPORT

RAMP - Collapse of Apron Catchpit during Aircraft Pushback

**Boeing B787-800**  
**Reg No A7-BCV**

A7-BCV/SINCID/001024

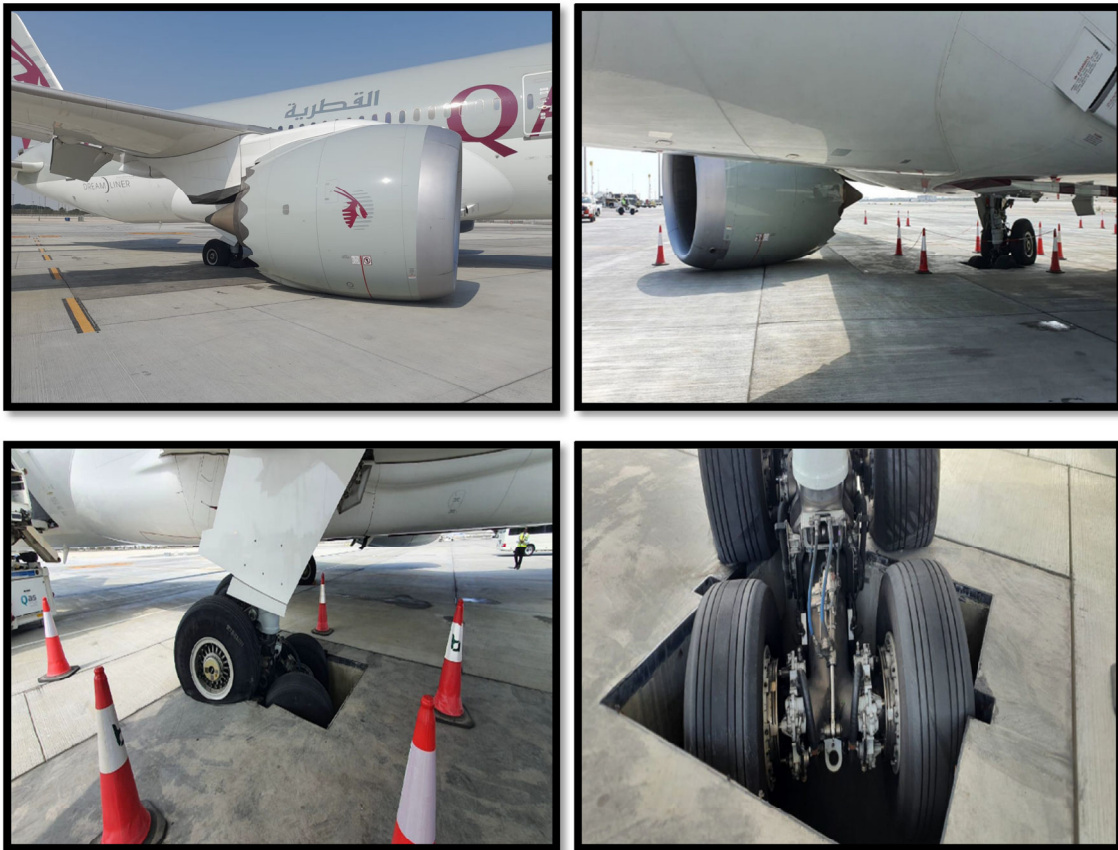
On 25 October 2024, a Qatar Airways (QR) Boeing 787-8 Dreamliner, registration A7-BCV, performing flight QR1379 from Doha to Algiers, was positioned at Parking Bay 634 on Apron 6 at Hamad International Airport. At approximately 05:45 UTC (08:45 Local Time). During pushback and engine start, the right-hand main landing gear (RH MLG) rolled over a grated catchpit covering a water drainage system, the grating's underlying structure gave way, dropping the panels into the pit, which caused the RH MLG to partially sink into the opening and become lodged, bringing the pushback operation and the aircraft to an abrupt halt.

The occurrence resulted in damage to the RH MLG, the underside of the No. 2 Engine (RH Engine), and various components in the nose gear area.

*Figure 1: A view of the aircraft, the right-side main landing gear assembly, and No 2 Engine touching the ground – from different perspectives.*

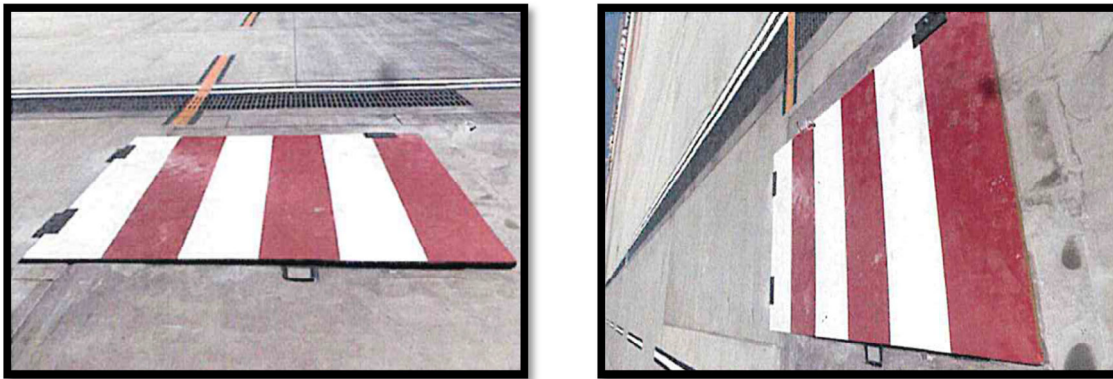
Figure 2: The suspected catchpits have been covered with metal sheets painted in red and white.

- Documentation of identified hazards and safety concerns.
- Isolation and visual marking (red and white metal sheeting) of potentially hazardous catchpits.

- Recommendations for repairing/reinforcing compromised catchpit and weak points shared with appropriate authorities for action.
